Proper Inspection Catches Screw-Machining Flaws

By E.M. Mount III*, B.W. Smith* and G. Pruner*

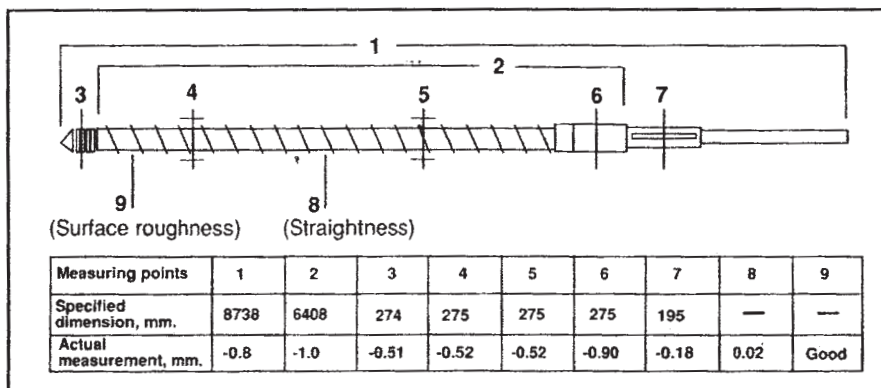
The purchase of screws to replace those with worn but proven designs is an important process in extrusion plants. Occasionally, new screws do not perform as expected despite meeting design parameters. This may be due to problems with the material of construction or to changes in the frictional coefficients of finishes and coatings. But there may also be hidden manufacturing flaws not discovered in common inspection procedures; an improperly machined taper in the transition section of the screw or in the variable solids-feed depth, for example; or, in a barrier screw, excessive barrier-flight clearance (Fig. 1).

Fig. 1. Close inspection reveals machining variations in screw.

During film manufacture, however, periodic disturbances were seen in film-gaging readouts and in visual uniformity of sheet, which rose to unacceptable levels as screw rpm increased above 70% of the sister screw's output. During a review of the line's performance, a transient rise in melt temperatures was observed and chart recorders were attached to the extrusion systems. While short-term temperature stability was better than 1° C and short-term pressure stability showed less than 1% variation, a transient upset was recorded every 7-10 min. in melt temperature and pressure. This upset is typical of an imbalance between melting and conveying functions. Upon a review and plotting of the screw inspection data, there was found a machining flaw in the taper of the melting channel that accounted for the poor long-term stability of melt temperature and pressure.

The hump in the transition section caused a restriction to the forward flow of solids in the solids channel.

The motor current also showed the effect of the increased pressure as an increased motor load during the transient. This indicated that the restricted solid flow was forcing the screw against the barrel, with the potential for higher wear. The problem was corrected by installing a new screw built to exact specifications and properly inspected prior to the installation. This required 16 weeks. In the meantime, the on-line recording was used to modify process conditions in order to minimize the problem and maximize productivity. The table compares the temperature profiles used to minimize the pressure build-up by increasing the melting rate in the area of the defect.

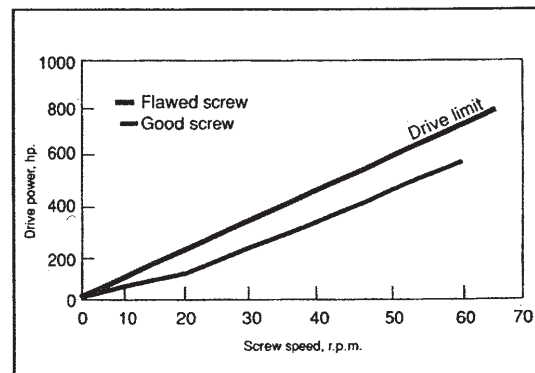
This required that pressure build behind the solid plug to push the solids past the hump. The resulting high-pressure point restricted melt and solids flow, causing a localized increase in temperature. As the pressure reached a point where the plug was pushed past the hump, there was a surge in pressure and output melt lasting about 1 minute.

Fig. 2. Screw flaws increase energy use.
